# Building Surveys and Reports

4<sup>th</sup> Edition

**James Douglas BSc, MRICS, MBEng, FHEA  
and Edward A. Noy FASI, ARSH**

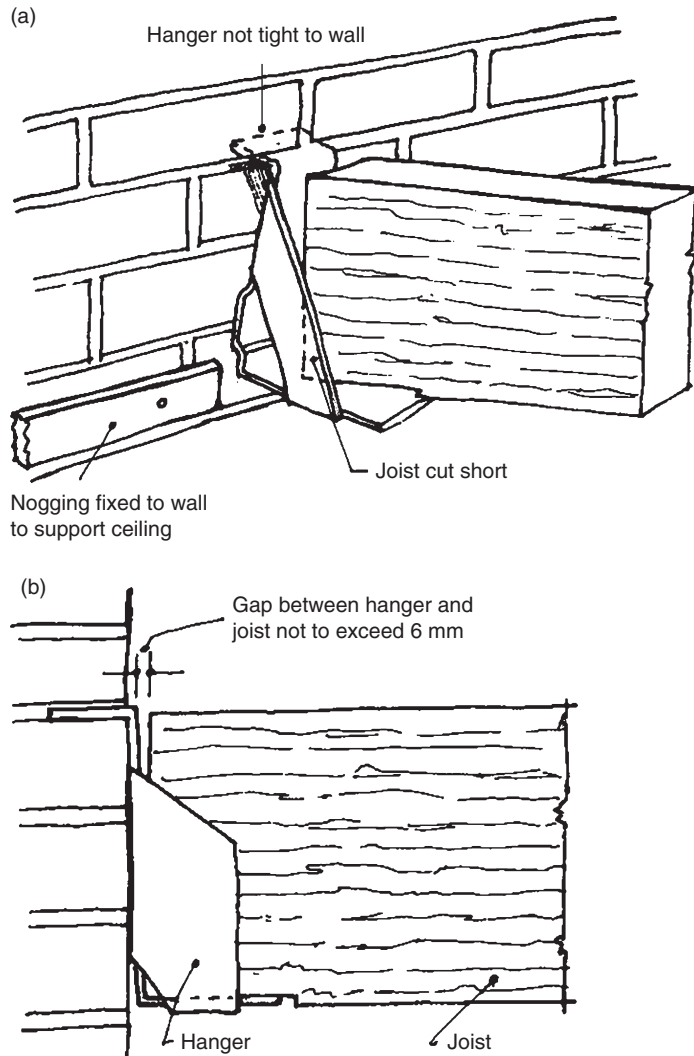
**Figure 12.2 Use of metal joist hangers: (a) incorrect positioning; (b) correct positioning**

- Hangers should be tight against the face of the masonry.
- Incorrect grade of hanger used. It is important that hangers are not used with masonry of lower strength than the hanger grade marking. Hangers should comply with BS 6178 Part 1 and are made for minimum masonry crushing strengths.
- Sometimes joists are cut short leaving a large gap between joists and back plate of hanger. This may cause hangers to move and the floor to settle.
- Check to ensure that no damaged or corroded hangers have been used.
- Check that the undersides of the joists are properly notched to accommodate the hanger flanges.

- (8) In modern properties metal joist hangers have been used extensively. Unfortunately, recent surveys have found instances where the hangers or joists have failed due to one or more of the following causes (see Figures 12.2a and b).

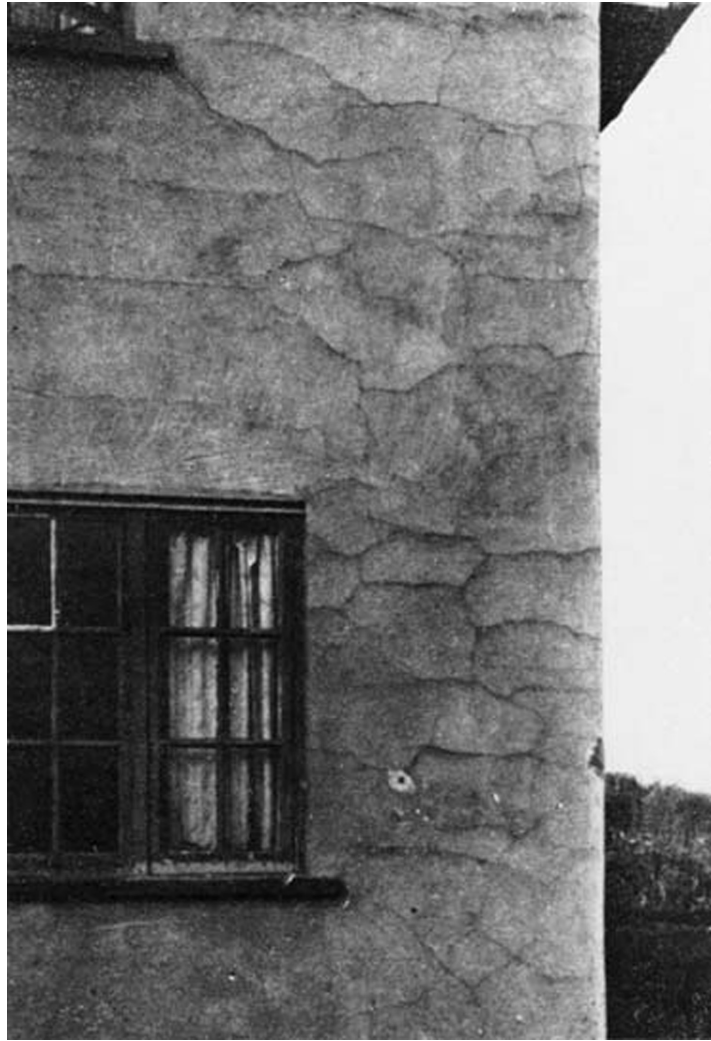
**Figure 13.1** Cracked rendering as a result of sulphate action

- Rendering consisting of cement and sand without the inclusion of lime and applied with a floated finish will often produce 'map' patterns. In exposed conditions this type of rendering will lead to loss of adhesion due to frost action and provide damp conditions necessary for sulphate attack. Figure 13.1 shows cracking of rendering as a result of sulphate action.

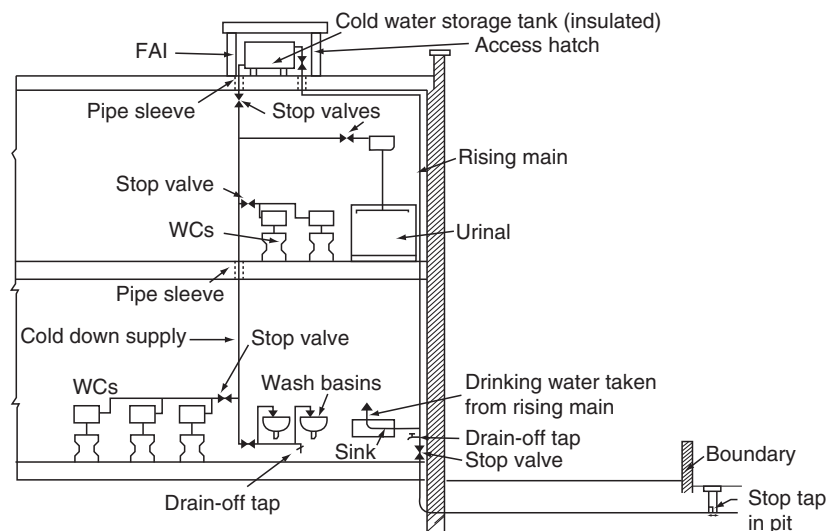
**Figure 14.1** Layout of cold water supply to small office block

The distribution of cold water through a building so that draw-off points can be adequately served depends on the requirements of the local water authority and the available pressure on the mains (Figure 14.1).

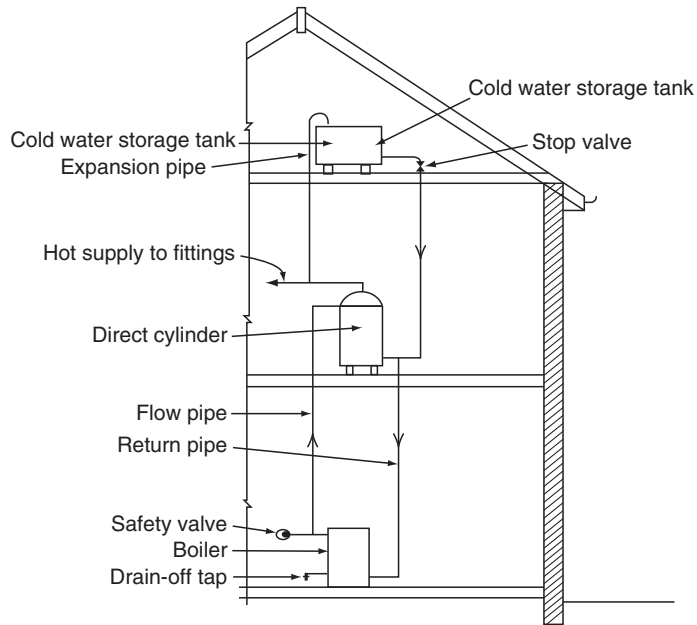
In direct heating systems the principal components are boiler; flow and return pipes; hot water storage cylinder; cold water supply pipe; expansion pipe and draw-offs (see Figure 14.2). Furring of pipes in this type of system is common in 'hard water' areas.

**Figure 14.2** Layout of direct heating system

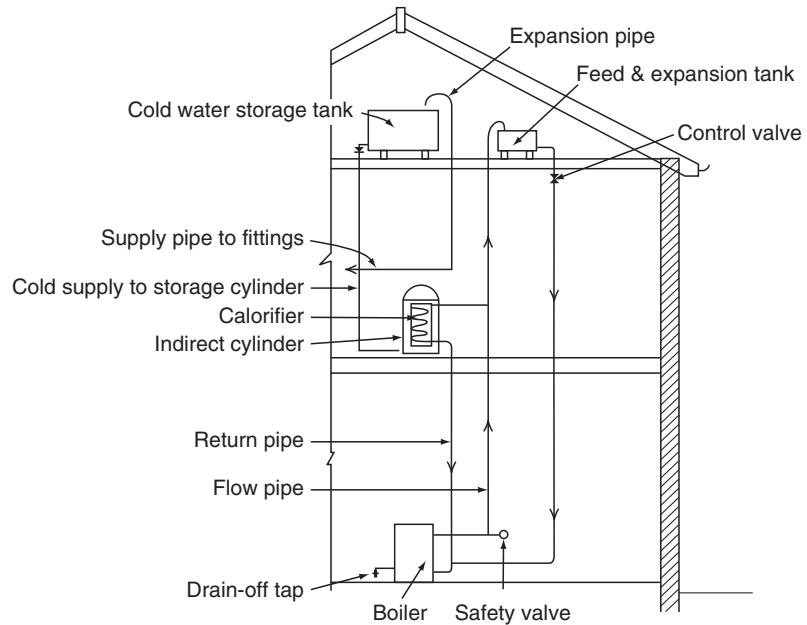
**Figure 14.3** Layout of indirect heating system

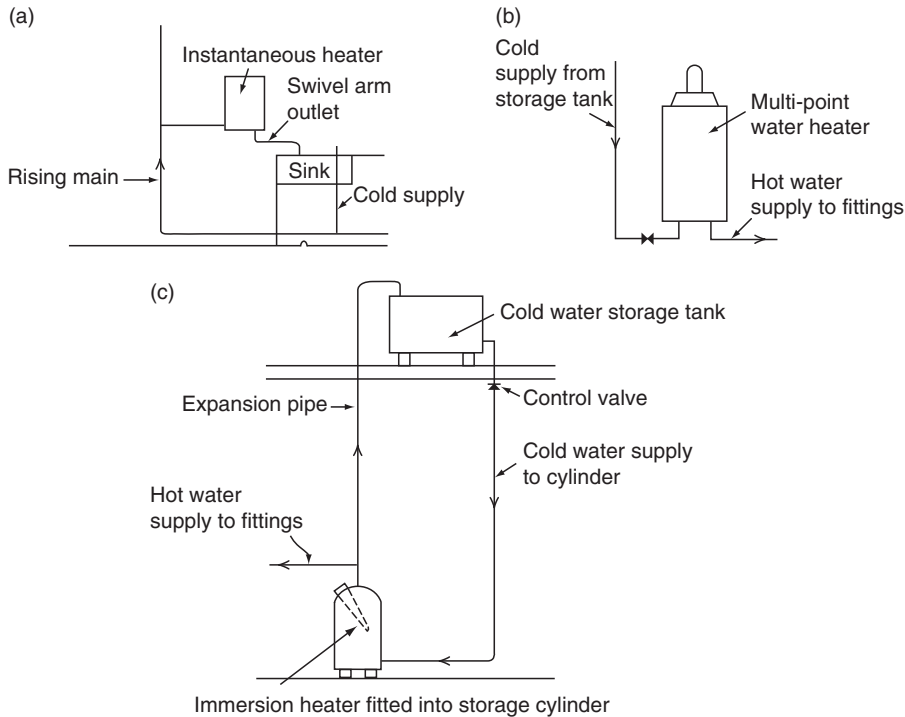
Wall mounted water heaters can be heated by gas or electricity. The instantaneous type is usually found above a sink unit in domestic properties and does not take up valuable floor space (Figure 14.4a). The water is heated at a single point and is supplied through a swivel arm outlet. The multi-point heaters can be heated by

**Figure 14.4** (a) Wall mounted instantaneous heater. (b) Wall mounted multi-point heater. (c) Heating water by electric immersion heater

gas or electricity. They receive the cold supply from a cold water storage tank which then supplies hot water to several fittings (Figure 14.4b).

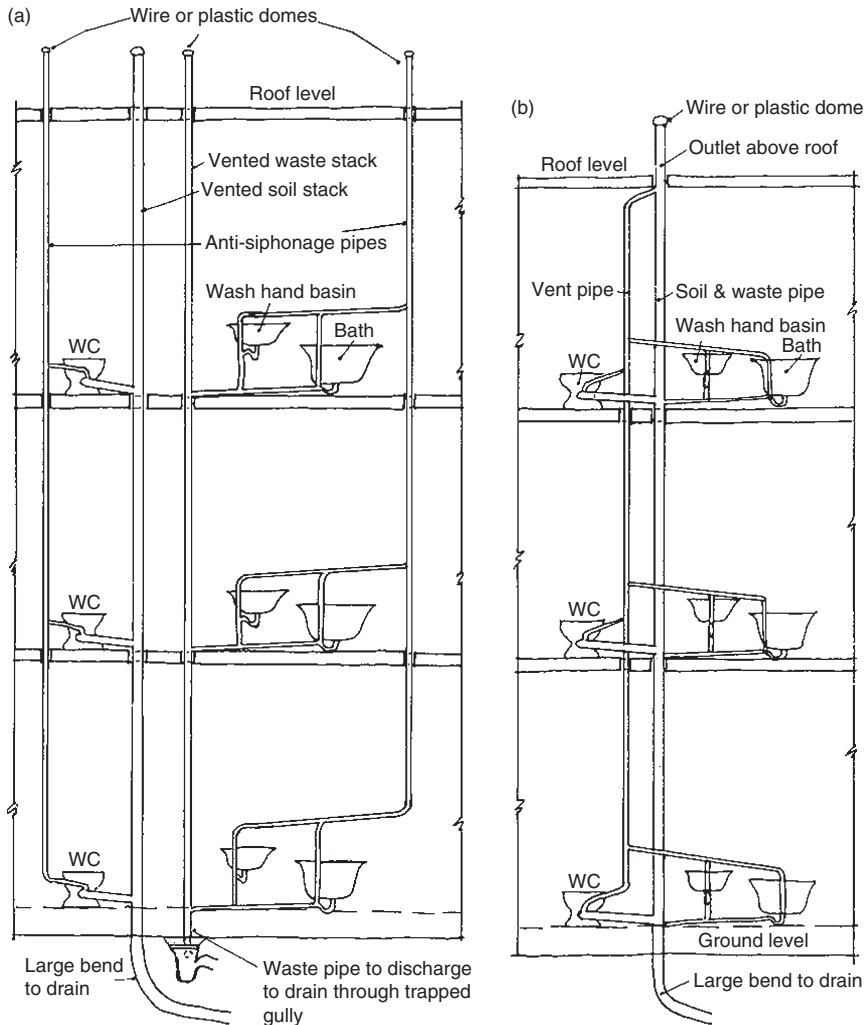
Figure 14.5 (a) Two pipe system for block of flats. (b) One pipe system

drain through a trapped back inlet gully, and the discharge from the water closets is direct to the drain. This system has a disadvantage in regard to the present day use of detergents and is now seldom used (see Figure 14.5a).

In this system the soil and waste are conveyed together in one pipe with ventilating pipes connected to each fitting and sized according to the loading of the installation. The main stack is connected directly to the drain (see Figure 14.5b).

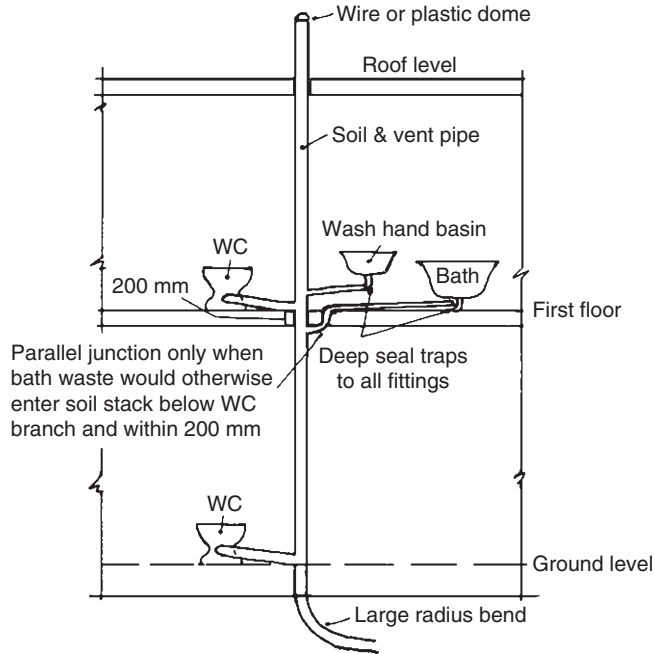
**Figure 14.6 Single stack system**

This is a much simpler system, does not employ separate ventilating pipes and is commonly used although it is based on strict rules which must be observed, e.g. deep seal traps must be used on all fittings (see Figure 14.6).

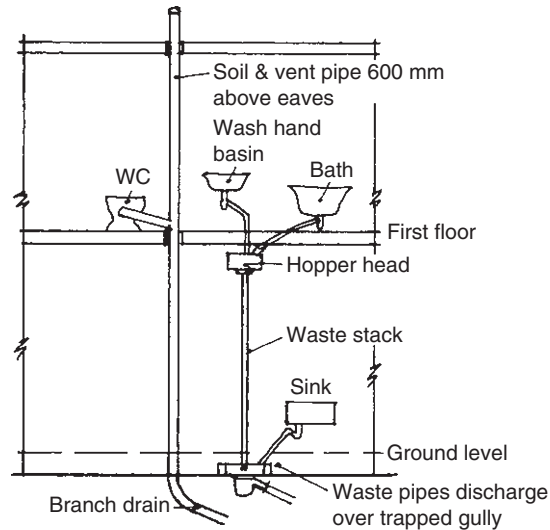
**Figure 14.7 Disposal of soil and waste water in older domestic properties**

In many domestic properties built before World War II the surveyor will find that the waste pipes from fittings above ground level, such as baths, basins and showers, discharge into hopper heads and the sinks at ground level discharge over a trapped gully. The WC is usually connected to a ventilated soil pipe. The waste pipe and hopper are not a satisfactory method and will often be found to be partially blocked with slimy soap and hair etc., and in very cold weather the waste water will freeze and possibly fracture the pipes (see Figure 14.7).

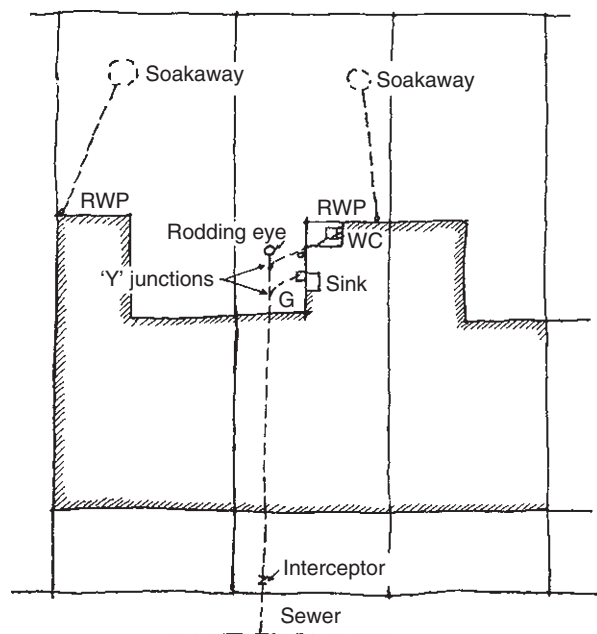
**Figure 15.1** Soil drainage system to terraced housing erected before 1900

If inspection chambers are not visible on site, the possibility that they may have been covered up by raised flower beds, pavings or rubbish should not be ruled out. If, however, inspection chambers cannot be located, there is a strong possibility that the building is still equipped with the original system which was probably installed some time between 1850 and 1880. Such a system was usually laid in 4" or 6" salt glazed pipes with clay joints and without any form of concrete bed. In the case of terraced houses, the most common layout was a straight run under the house from the outside WC to the sewer. This meant that the soil branch drain connected to the WC outlet and vented to the open air and went directly to the main drain while a second pipe took the waste water from the kitchen sink to an outside trapped gulley. Sometimes the WC connection entered the main run with a 'Y' junction, the main run then being extended via an easy-bend up to yard level where it was capped off with a rodding eye. However, it was fairly common practice to form a junction by cementing the end of a 4" branch pipe into a hole cut into a 6" main drain (see Figure 15.1).

Drainage systems of the kind shown in Figure 15.1 are seldom found today. They do not satisfy any of the requirements of the current Building Regulations in that they are unlikely to be watertight and not laid to a self-cleansing fall. The surveyor can safely assume that, if no inspection chambers can be found, a new drainage system must be provided as the system will certainly be condemned by the Environmental Health Officer. Where inspection chambers are found on nineteenth century properties similar to that shown in Figure 15.2 it is usually an indication that the drains have been relaid at a more recent date. An examination of the type and condition of the brickwork and channels can give an indication of the age of the system.

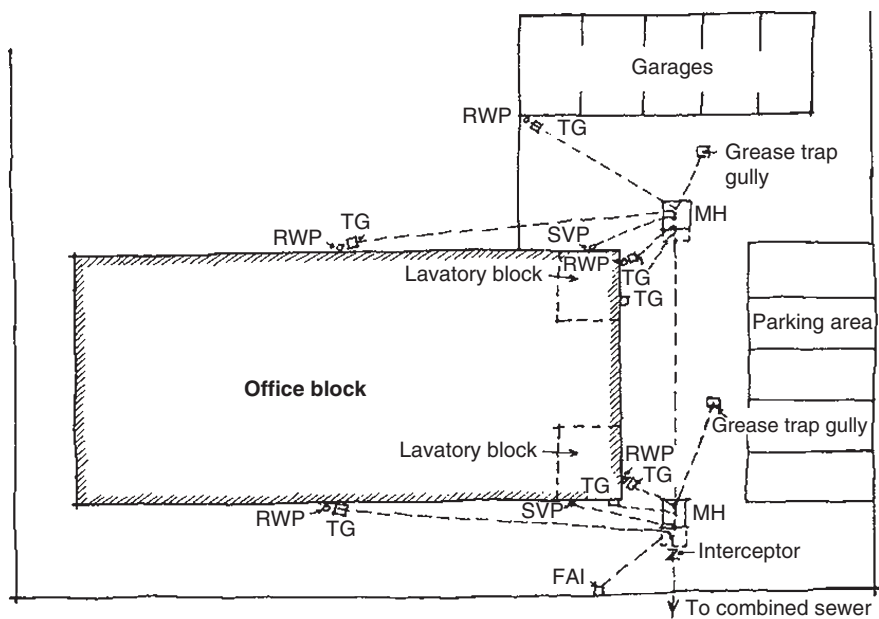
Figure 15.4 Typical combined system for small commercial building

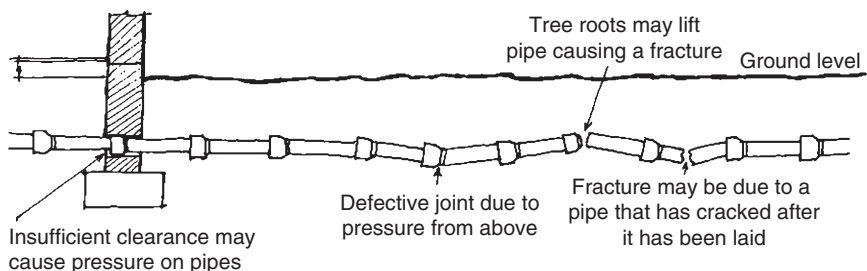
**Figure 15.5** Defects due to movement of ground through settlement, shrinkage or tree roots

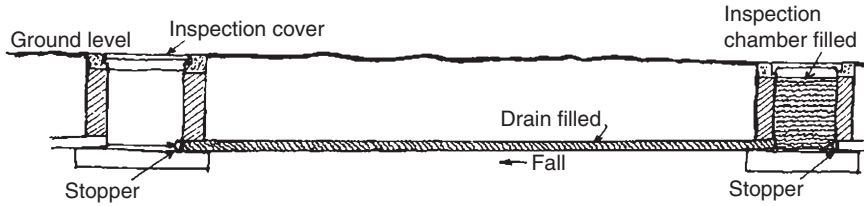
**Figure 15.6** Water test applied to section of drain between two inspection chambers

The only certain method of demonstrating that a drain will hold water is to fill it with water and note if the level drops. This can usually be done by gaining access to the drain at the lowest inspection chamber and stopping the inlet with an expanding stopper. Another stopper should be fitted to the inlet (or to each inlet if there are more than one) at the next inspection chamber higher up. These positions are shown in Figure 15.6 which is a section through a drain being tested. The higher inspection chamber is then filled with water and the distance from the top of the cover frame to the top of the water carefully measured and then left for about 1.5–2 hours. If the water level in the chamber goes down by any appreciable extent a leakage is indicated. There will be a slight lowering of the water level even

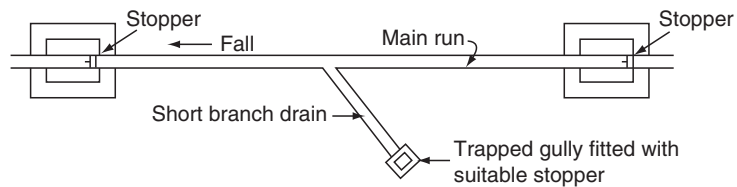
**Figure 15.7** Water test applied to main and branch drain

Short branches connected to a main drain between inspection chambers as shown in Figure 15.7 should be tested with the main drain. The gully should be fitted with a suitable stopper and any confined air in the gully should be drawn off as the pipe fills with water, using a rubber tube passed through the seal of the gully. The shorter the lengths tested at one time the better, as the job of opening the ground and searching for defects can be confined to those sections in which defects are indicated by test.

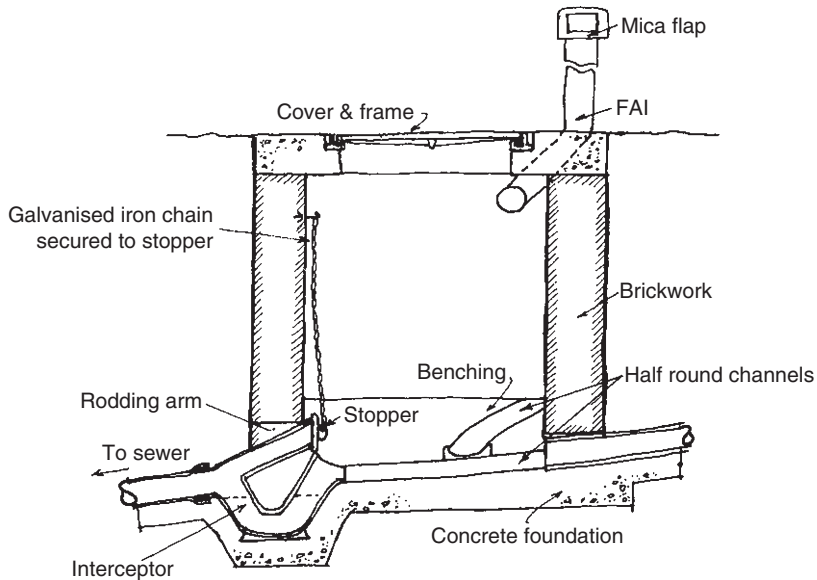
**Figure 15.8** Section through interceptor and inspection chamber

The interior of each inspection chamber should be carefully examined and the construction and condition of the following parts noted (see Figure 15.8):

It is advisable to recommend that a galvanised iron chain is provided and secured to the chamber wall as shown in Figure 15.8. Where an interceptor is provided, a fresh air inlet with a mica-flap is theoretically necessary as shown in Figure 15.8. It should be located away from windows and doors and sited where the front will not be accidentally damaged. The mica-flaps should be closely examined. They may cause a nuisance by acting as a foul air outlet if the flaps are damaged.

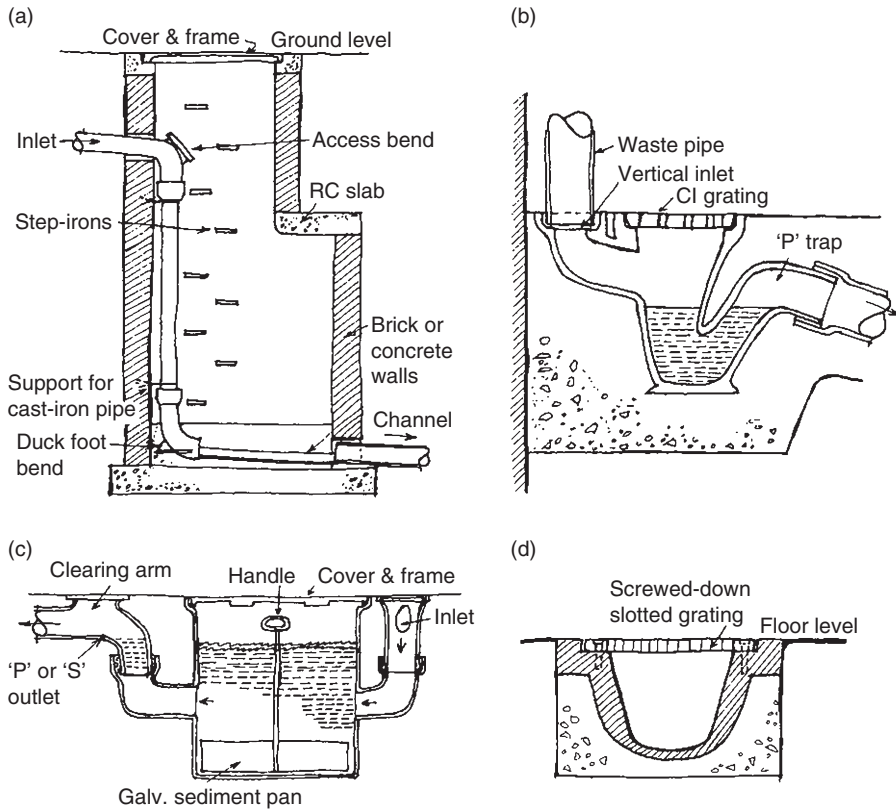
**Figure 15.9** (a) Section through back-drop inspection chamber. (b) Back inlet gully. (c) Grease trap. (d) Drainage channel

An inspection chamber incorporating a vertical drop for the purpose of connecting to a sewer or drain at high level to one at a lower level is known as a back-drop inspection chamber, or tumbling bay. The vertical drop is usually constructed outside the chamber, but may be constructed inside provided there is sufficient space in the chamber as shown in Figure 15.9a. If the vertical drop is constructed

This type of gully is used outside a building and is fitted with a vertical or horizontal inlet as shown in Figure 15.9b. For use within a building this type of gully must be fitted with a sealing cover and frame secured with screws and washers. The inlet should be connected below the grating, but above the water seal; be self-cleansing; have a seal of at least 50 mm and a flat base for bedding in concrete. During the examination the surveyor will find that many of the older type gulleys will not comply with these requirements and are often fitted with insanitary connecting channels to receive the discharge from waste pipes or, alternatively, the waste pipes discharge over the top of the gully grating.

In normal domestic drainage grease traps need not be provided, but where substantial quantities of grease are discharged into a drainage system from large kitchens and wash-up rooms a grease trap should be provided. The intention is that the cooling effect of the water in the trap solidifies the grease which rises to the surface and collects in a solid mass. The heavier matter collects in a galvanised sediment pan situated at the base of the grease trap. The grease trap consists of a cast iron or galvanised steel tank fitted with a single seal cover at ground level. A vent grating at ground level is fitted close to the inlet and the connection to the main drain is fitted with a 'P' or 'S' outlet. The disadvantages of these traps are that they are rarely cleaned and the removal of grease is usually an offensive operation. However, the surveyor will often find that the increased use of detergents has lessened the need for providing grease traps or gulleys (see Figure 15.9c).

The type of floor channel shown in Figure 15.9d is usually found in industrial buildings. It consists of a cast-iron or precast concrete half-round channel fitted with a light, medium or heavy duty slotted grating. Some channels have a built-in fall with an outlet at one end connected to the drainage system.

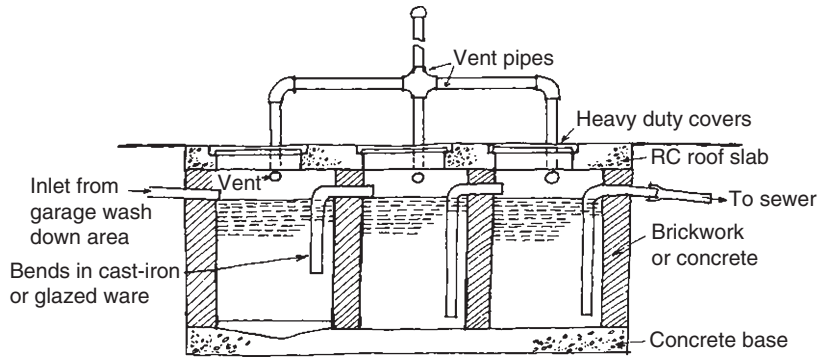
**Figure 15.10 Petrol interceptor**

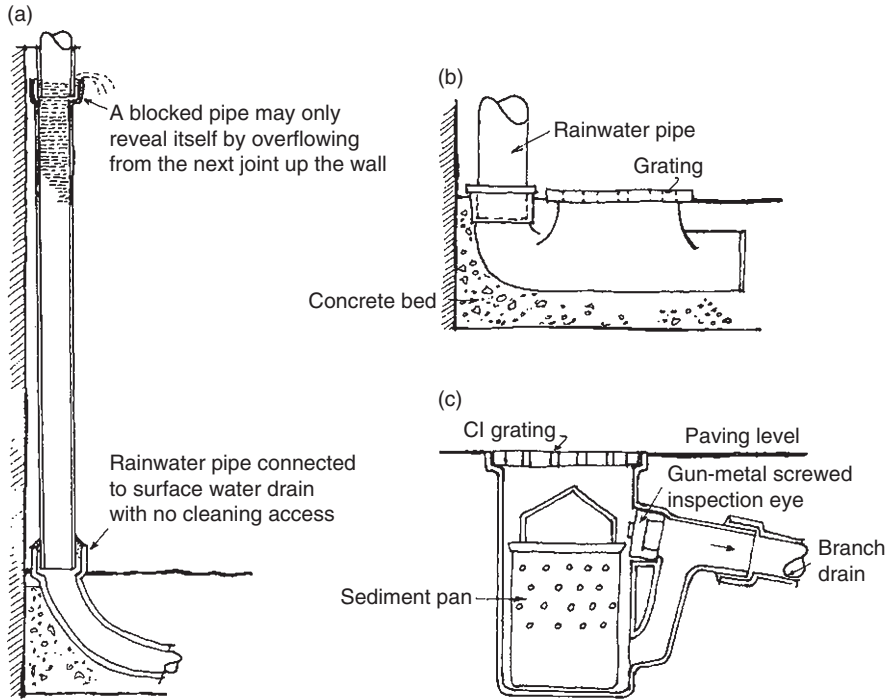
**Figure 15.11** (a) Rainwater pipe connected direct to surface water drain. (b) Rainwater shoe. (c) Yard gully

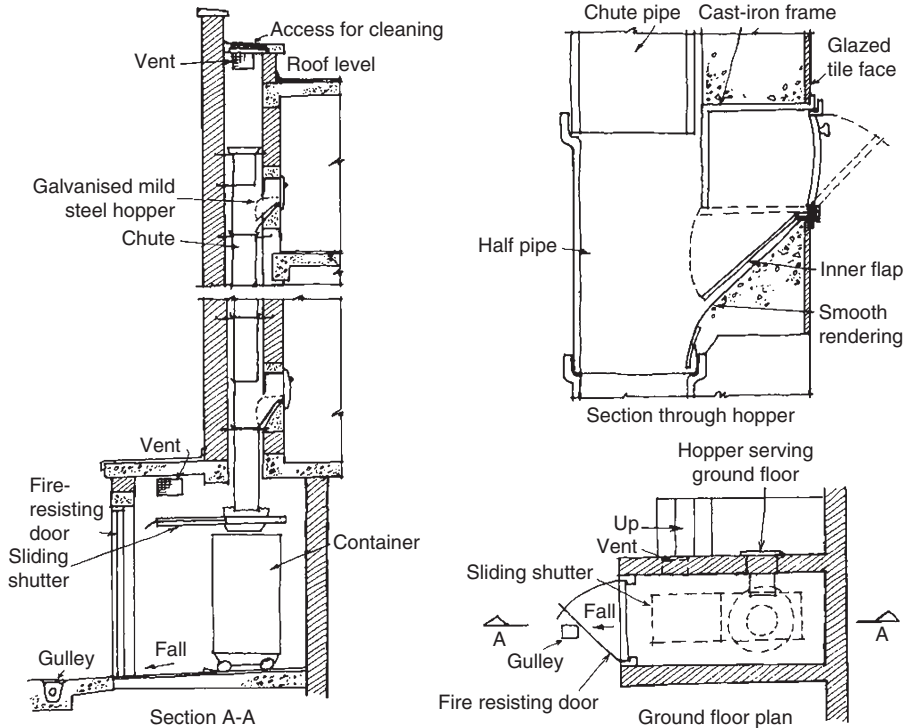
**Figure 15.13 Typical refuse chute**

The problem of refuse disposal in large blocks of flats and in some commercial buildings is usually overcome by refuse chutes. Figure 15.13 shows many of the standard features of a refuse chute and storage chamber which are required by the Building Regulations. The chute consists of a vertical pipe with a minimum diameter of 457 mm although some older types will be approximately 375 mm. The pipes must be constructed of non-combustible impervious materials such as salt glazed ware or vitreous enamelled iron, though in modern buildings spun concrete is used. The chute runs from top to bottom of the building and has an inlet hopper on each floor. At ground floor level the chutes discharge into a wheeled container in a specially constructed chamber consisting of a brick structure with a concrete roof slab and floor fitted with a fire-resisting door. Adequate ventilation is a necessity and both chamber and chute must be ventilated as shown in Figure 15.13.

- Hoppers for access to the chute at each floor level are usually galvanised mild steel. When open, an inner flap closes thus shutting off the main chute. When the hopper is in the closed position the inner flap drops allowing the contents to fall into the chute. Hinges and fastenings should be checked for ease of working. The hopper should have a surround at least 300 mm wide on the external face consisting of glazed tiling or other impervious material.
- The chute must be ventilated at the top and so positioned as not to transmit foul air in such a manner as to become prejudicial to health.

- A hinged cover for access at the top of the chute for cleaning is desirable, as shown in Figure 15.13.
- The chamber containing the wheeled container must have a fire resistance of 1 hour and be impervious to moisture. The floor of the chamber should be laid to a fall towards a trapped gulley situated immediately outside the chamber to enable the floor to be washed down. The construction of the walls, floor and roof should be checked as described in Chapters 5, 6 and 7.

Although the chute is of vital importance it is generally impossible to examine its condition and effectiveness visually. Unless there is evidence that the chute is defective it must be accepted that it is in reasonable condition. The construction and condition of the following parts should be noted.

- The entrance door to the chamber must have a fire resistance of 30 minutes. It is important to check the condition of the door and frame. In the writer's experience the chamber doors are often damaged by the removal of the wheeled container.

- The inner surface of the chamber walls should be lined with a smooth impervious material. Many chambers are often lined with quarry tiles, which are easily broken or may have become loose due to impact damage.
